ASPENHOFF LAKE DAM

WARREN COUNTY, MISSOURI

MO 11006

**PHASE I INSPECTION REPORT  
NATIONAL DAM SAFETY PROGRAM.**

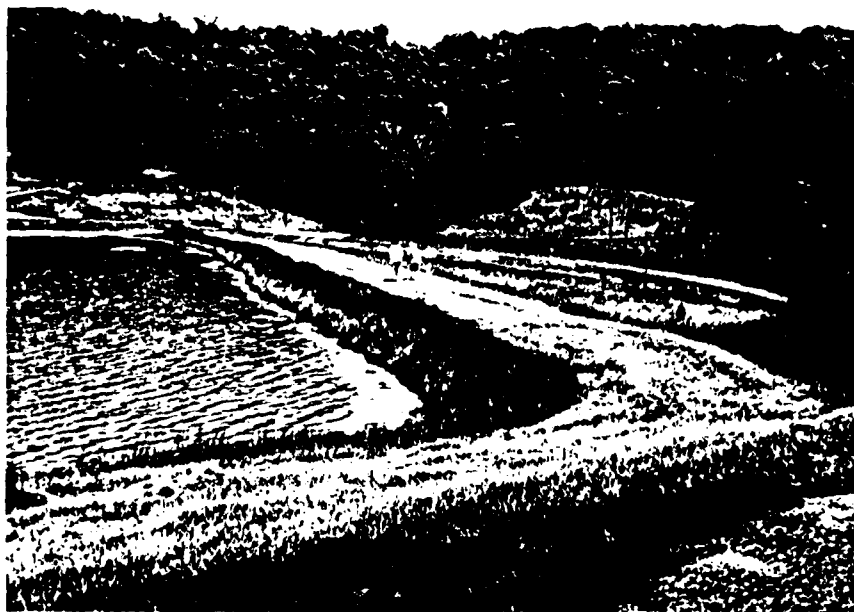
01

The upstream slope has no riprap protection and has consequently undergone minor erosion from wave action. No trees or brush were growing on the embankment. Minor rodent activity was observed on the upstream embankment slope.

The upstream slope of the embankment near the crest does not contain riprap protection and has undergone some wave erosion. This condition does not appear to be serious at this time, but should be watched in the future for further erosion, and repairs made as required. The rodent activity on the embankment should be eliminated.

The embankment appears to be in generally good condition. The erosion on the upstream embankment slope due to wave action should be watched and repairs made to the slope as required. Rodents should be eliminated from the embankment.

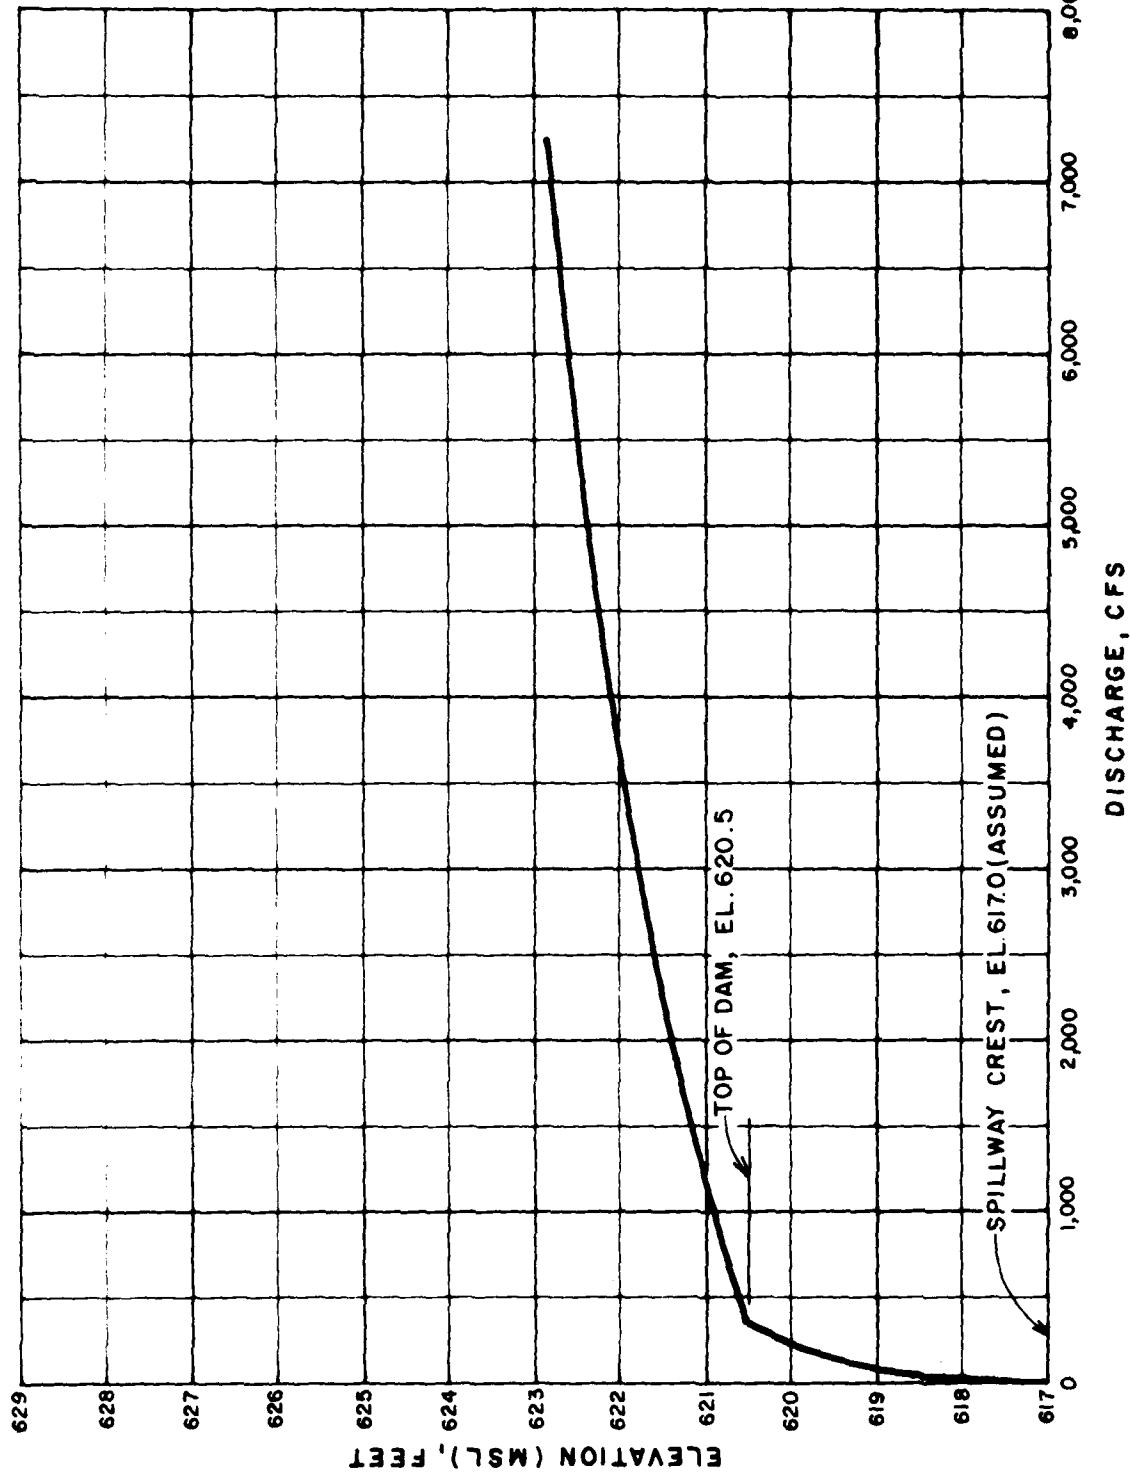
ASPENHOFF LAKE DAM (MO. 11006)  
SPILLWAY & OVERTOP RATING CURVE

The spillway capacity of Aspenhoff Lake Dam was found to be "Seriously Inadequate". The spillway and the reservoir system will accommodate only 22 percent of the PMF without overtopping the dam.
